FUDS Site Closeout Report

**Pedro Dome Radio Relay Station
Fox, Alaska**

March 27, 2002
USACE-POA-EN-EE (Haviland)
rev. 4

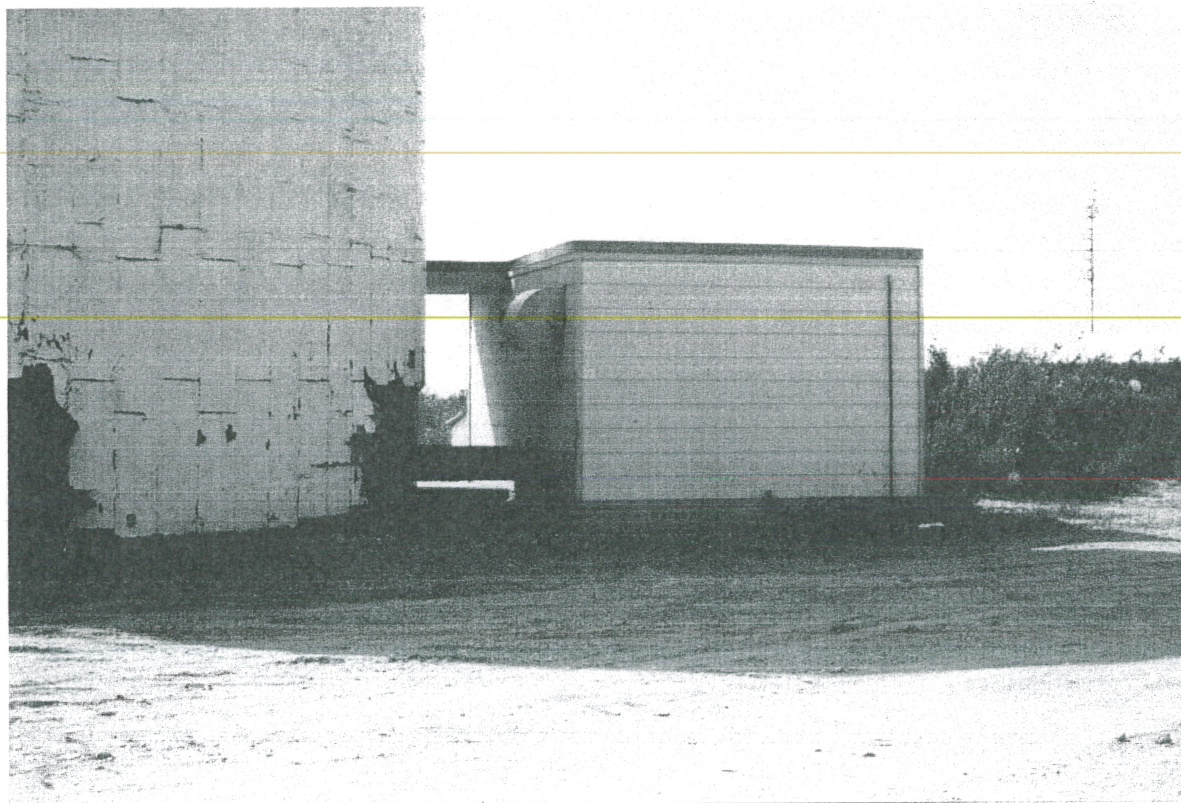
Figure 7 – Tank and Pumphouse - July 15, 1993

Pedro Dome, Tank & Pumphouse before demolition, July 15, 1993

In 1993, the second removal action was also conducted by OSC under contract to USACE-POA. This removal action demolished the water tank and pumphouse. Steel from the water tank demolition was recycled. Demolition debris from the water tank and pump house was landfilled at the Fairbanks North Star Borough (FNSB) state permitted landfill in Fairbanks, Alaska. Approximately 600 pounds of ACM asphalt shingles from the water tank was removed and disposed of at the FNSB landfill. About 340 CYs of PCB-contaminated soil was excavated and disposed at the EnviroSafe Services EPA permitted landfill in Grandview, Idaho. Contract capacity was reached prior to removal of all contaminated soil. The excavation was lined with plastic sheeting and backfilled with clean soil (See Figures 7, 8, and 9).

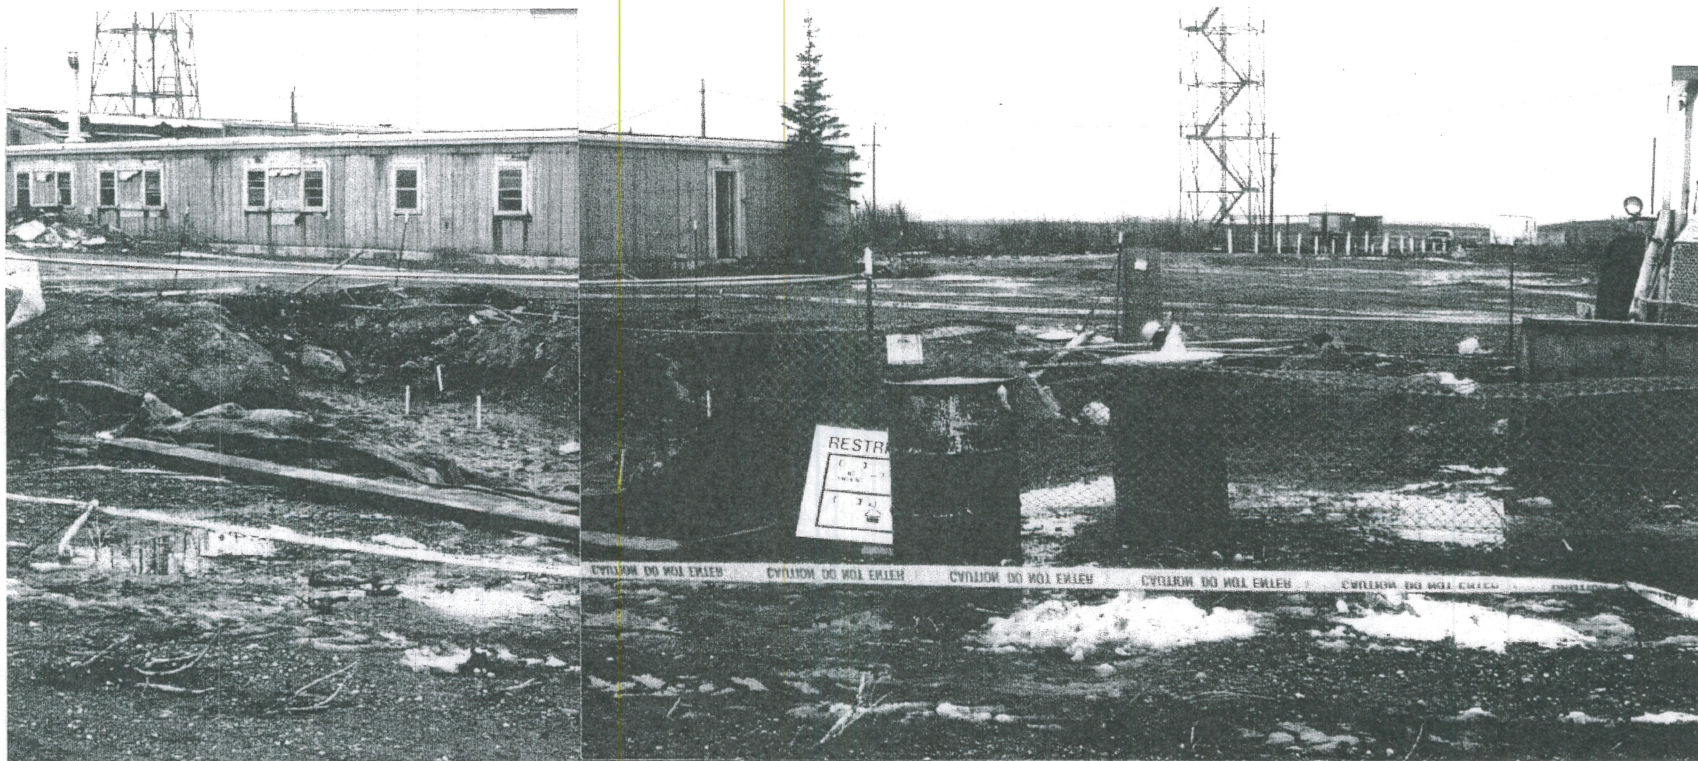
Figure 9 - Maximum Excavation – 1993

Pedro Dome, Maximum Excavation at former water tank site. OCT 1993

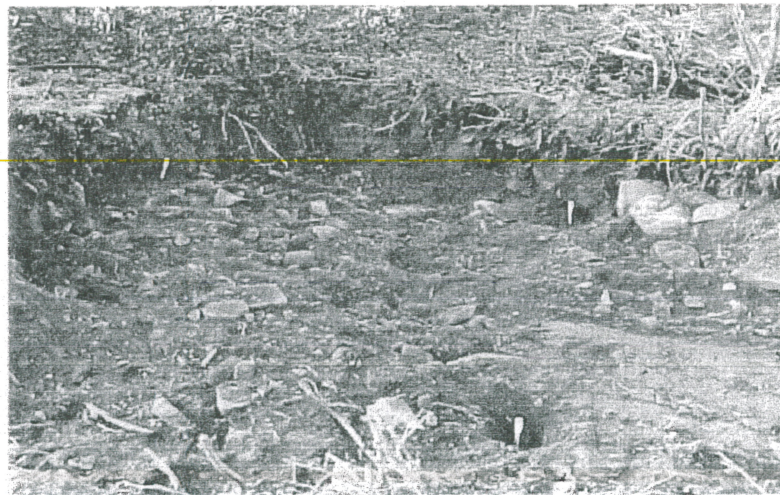
Figure 11 - Excavation & Sample Locations at Swale

41 Proj# 98-01-02 Date: 8-26-99
 Project Name: Pedro Dome Location: Pedro Dome, AK
 Facing Direction: South
 Description: Sample locations at swale excavation.
 Contractor: Linder Construction Contract #: DACA85-98-D-0015
 Roll# 3/9

In 1999, under contract to USACE-POA, Linder General & Environmental Contractors conducted the final removal action. Linder removed the clean soil above the liner, stockpiled it, tested it, and after verifying all contamination was below 10 mg/kg, used it for backfill. About 300 CYs of PCB-contaminated soil was excavated and disposed of at the EnviroSafe Services EPA permitted landfill in Grandview, Idaho. This soil was excavated from the area of the former water tank and pumphouse, and from an area near the drainpipe to the water tank (Figure 19). Approximately 47 linear feet of water line with ACM insulation was removed and disposed of at the FNSB landfill. All backfilled soil tested less than 10 mg/kg. The cleaner soil was backfilled near the surface, while soil testing close to (but below) the 10-mg/kg limit was backfilled deeper. To further reduce exposure, the top inch or so of the area was bladed into the excavation. Prior to backfilling, the excavations were lined with plastic sheeting (See Figures 10, 11, 12, and 13).

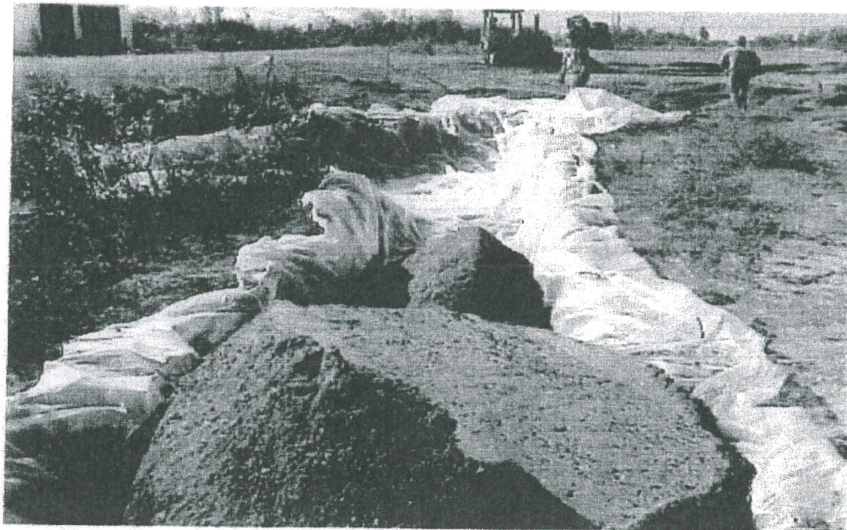
Figure 12 - Linear & Backfill at Swale

53 Proj# 98-01-02 Date: 8-27-99
 Project Name: Pedro Dome Location: Pedro Dome, AK
 Facing Direction: West
 Description: Install backfill material at pipe and swale excavation.
 Contractor: Linder Construction Contract #: DACA85-98-D-0015
 Roll# 4/17
